Manhole Inspection Summary

Manhole # S29SS_005MH

Insp Date: **5/15/07 9:45 AM**

Location Address: **505 29TH ST**

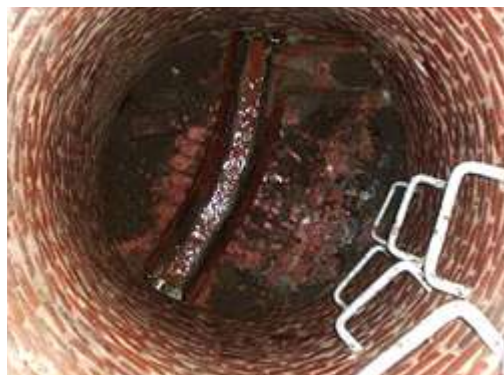
Top View

Bench debris.

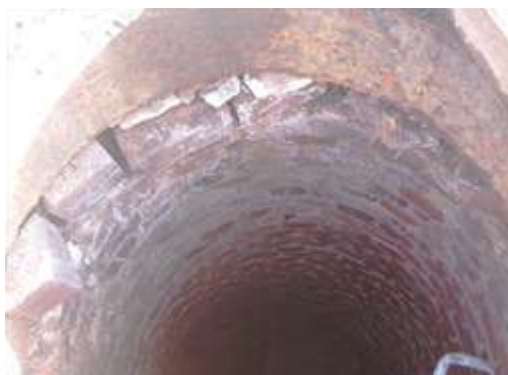
Defect

Frame leaks. Adjustment deterioration, loose brick and infiltration - other side.

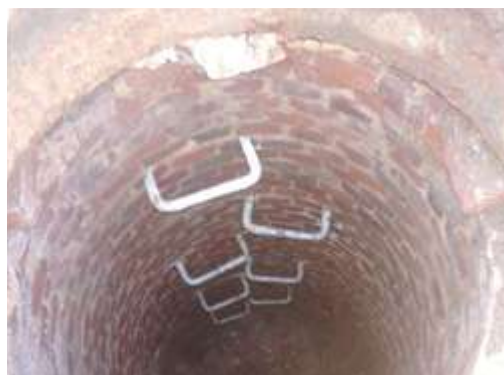
Defect

Frame leaks. Adjustment deterioration, loose brick and infiltration.

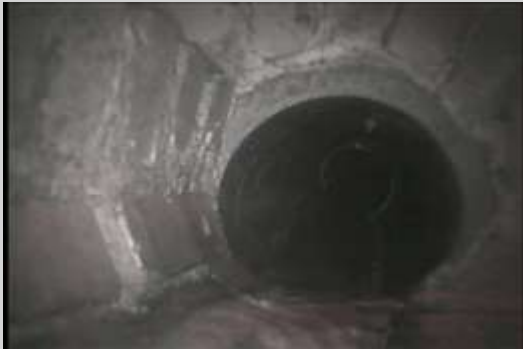
8 in. Circular Gravity Sewer Pipe Out @ 12 O'Clock

Infiltration: **Evidence** Pipe Seal Cond: **Unknown**

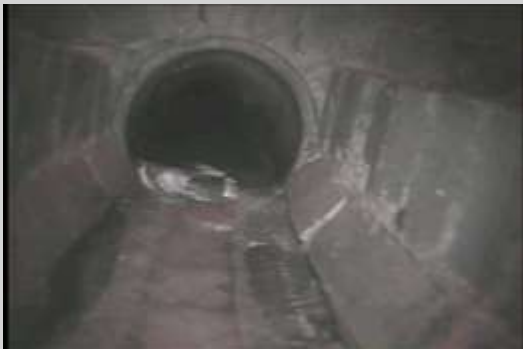
8 in. Circular Gravity Sewer Pipe In @ 8 O'Clock

Deposits: ☐ None ☐ Mud ☐ Sludge ☒ **Debris** ☐ Grease

Silt Depth: **0** (in.) Deposits Extent: **Light**

Infiltration: **Evidence** Pipe Seal Cond: **Cracked**
